MEMORANDUM

Re: Cumberland Dam Phase I Summary
Potomac River
Cumberland, MD
Project No. 1033.001

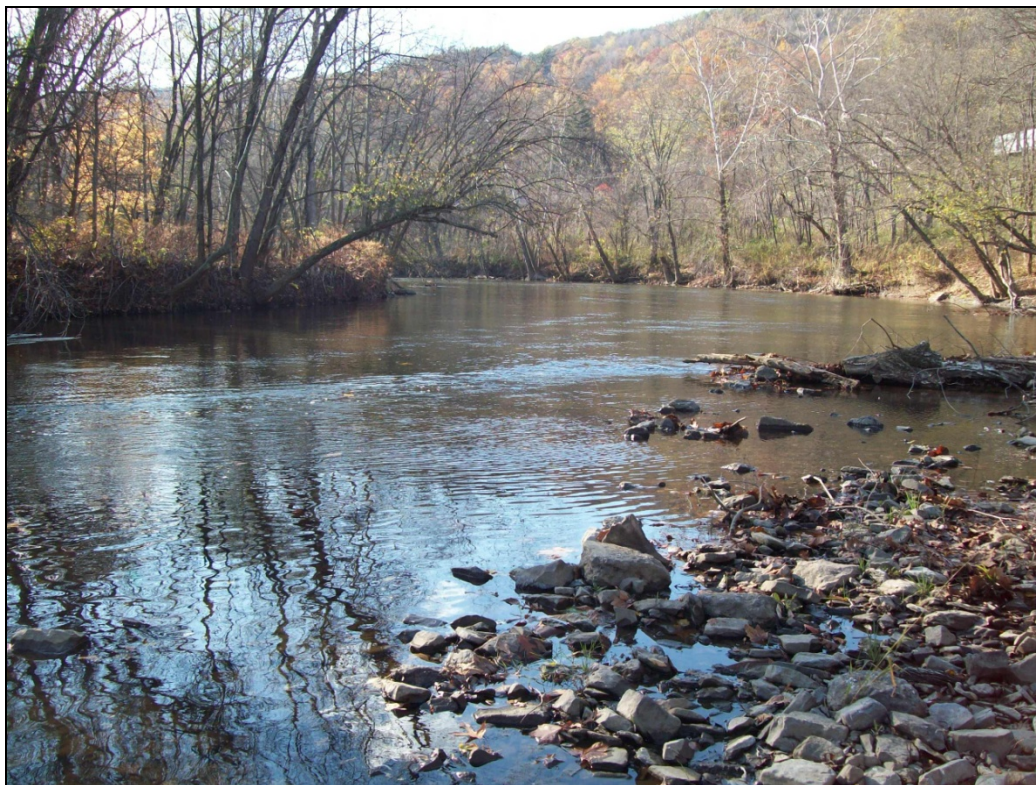
FIGURE 1. Riffle at upstream extent of impoundment approximately 10,000 LF upstream of Cumberland Industrial Dam.

The upstream extent of the impoundment was identified by the coincidence of (i) a pronounced increase in velocities at a grade-change / riffle feature (Figure 1), (ii) substrate dominated by gravels and cobbles and completely devoid of soft sediments, and (iii) a narrowing of the channel upstream of the riffle (also apparent in the attached aerial photo). Based on these observations at the time of survey the impoundment is approximately 1.9 miles long (10,000 LF).

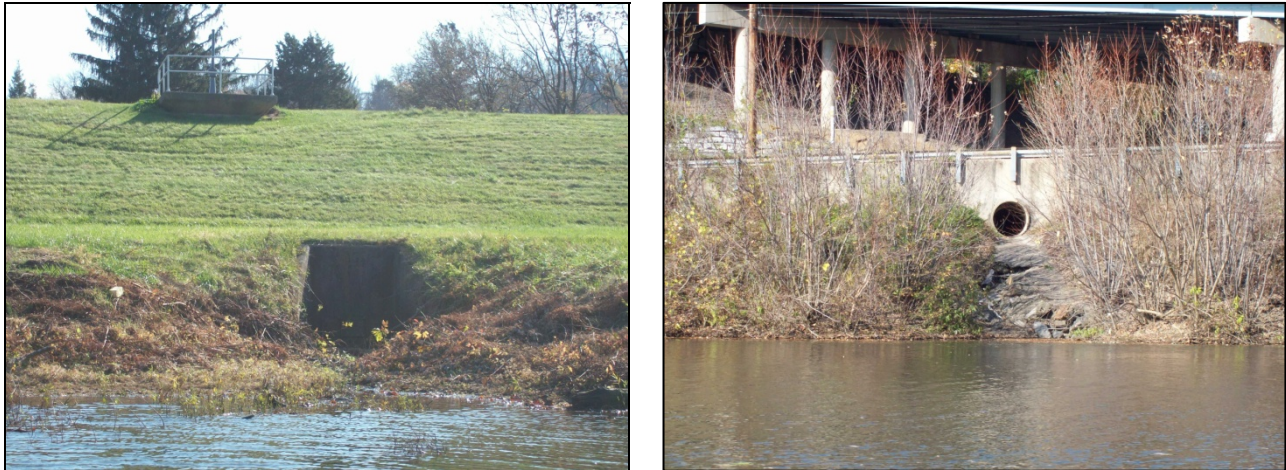
FIGURE 2. Levee drain outlet (a) and stormwater outfall (b) observed approximately 2,000 LF upstream of Cumberland Industrial Dam.

The impoundment was also investigated for general potential issues of concern related to dam removal. Multiple aging industrial buildings are situated adjacent to the channel or in the floodplain but present no significant concerns to dam removal. Several levee drains / stormwater outlets were observed with inverts below the water surface (Figure 2a). Seven small (<12 in. diameter) stormwater outfalls were observed and three larger stormwater outfalls (Figure 2a). None of the outfalls identified are anticipated to be vulnerable to scour or destabilization in the event the dam is removed and water level drops. While the function of levee drain outlets are unlikely to be compromised if the dam is removed, additional consideration may be warranted.
